Acceleration hole improvement

MACHINE TYPE: 121 – 121A

REFERENCE CODE: M.092

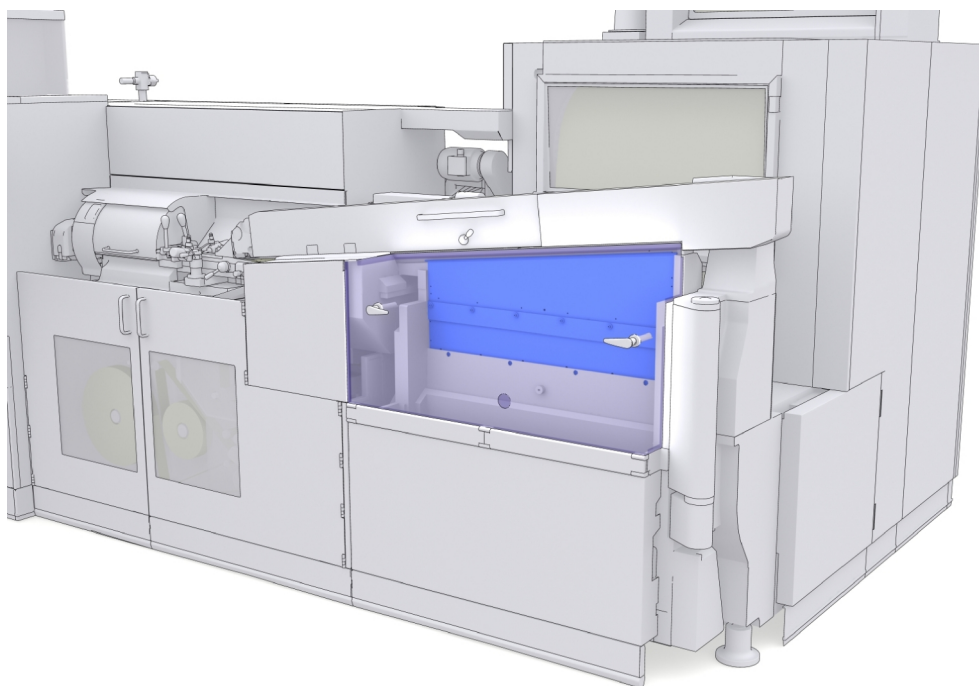
The kit features the replacement of the inner and outer walls of the suction chamber with new ones having a different geometry and a different number of the acceleration holes.

The hole diameter decreases from 2.5 to 2 mm while the hole total number increases from 5492 to 10508 and the height of the lateral vacuum chambers increases from 40 to 45 mm.

These modifications allow a better handling of the tobacco flow increasing the air velocity close to the wall, reducing the air velocity gradient close to the wall and reducing the turbulence in the vacuum lateral chambers.
